Volume II-Problem Area Analysis

Luzerne County Act 167 Phase II

Stormwater Management Plan

June 30, 2010

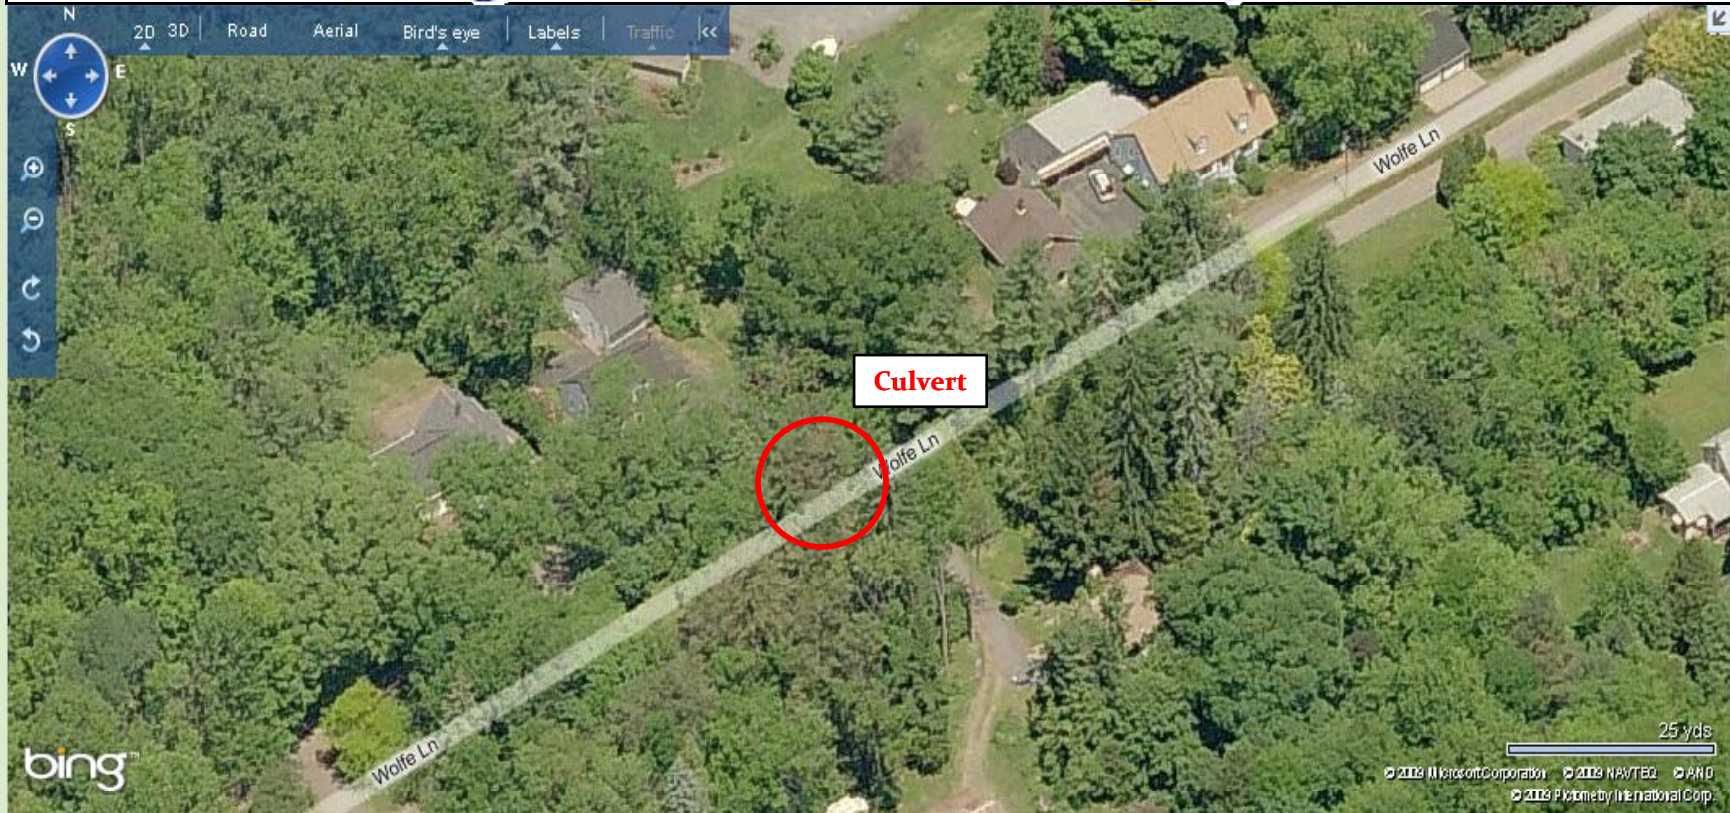
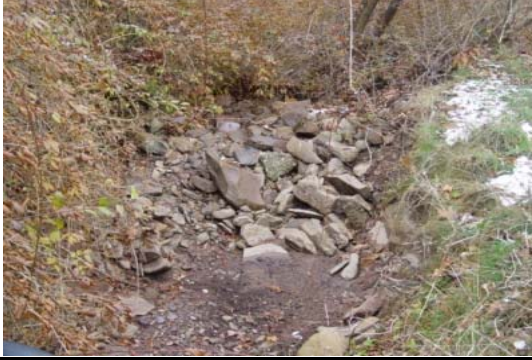
Problem Area ID:	CNB003	Inspected By/Date:	PAK 11/26/2008
Municipality:	Conyngham Borough	Checked By/Date:	DEW 2/18/2010
Subwatershed:	Nescopeck Watershed

Explanation: Conyngham Boro reports flooding, drainage, and erosion problems on the western side of South Main Street. Based upon the map location and site observations, this area was deemed to be located off of Wolfe Lane which intersects South Main Street. A culvert system that had significant channel erosion upstream of the culvert was found. Downstream of the culvert was a large scour hole.

Stream name:	Trib to the Little Nescopeck Creek		
Drainage Area (mi ²)	0.09		
Calculation Method	Rational Method		
C (Tc)	0.28 (60 min)		
Storm Frequency (Yrs)	Rainfall (in)		Peak Discharge (cfs)
2	1.31	21	0.36
10	1.86	30	0.52
25	2.19	35	0.61
50	2.46	40	0.69
100	2.76	47	0.82
500	3.57	57	0.99
*Type of Problem (Highlight all that apply):		Description	
Flooding	Deficient Bridge/Culvert	A 36" culvert is present under Wolfe Lane. The channel side slopes are beginning to erode upstream of the culvert and a scour hole is starting to form immediately downstream of the culvert.	
Erosion	Sedimentation		
Water/Groundwater Pollution	Other		
Potential Solutions			
Streambank erosion at Wolfe Lane off of S. Main Street, has been identified by the municipality. Based upon general field observations, this problem is believed to be caused by an undersized culvert that is producing high velocities and insufficient outlet protection. Possible implications are undercutting of the bank resulting in instability, loss of trees and vegetation, and downstream deposition of sediment. Possible solutions to this problem are A) stabilization of the stream bank and armoring banks or B) replacing structure.

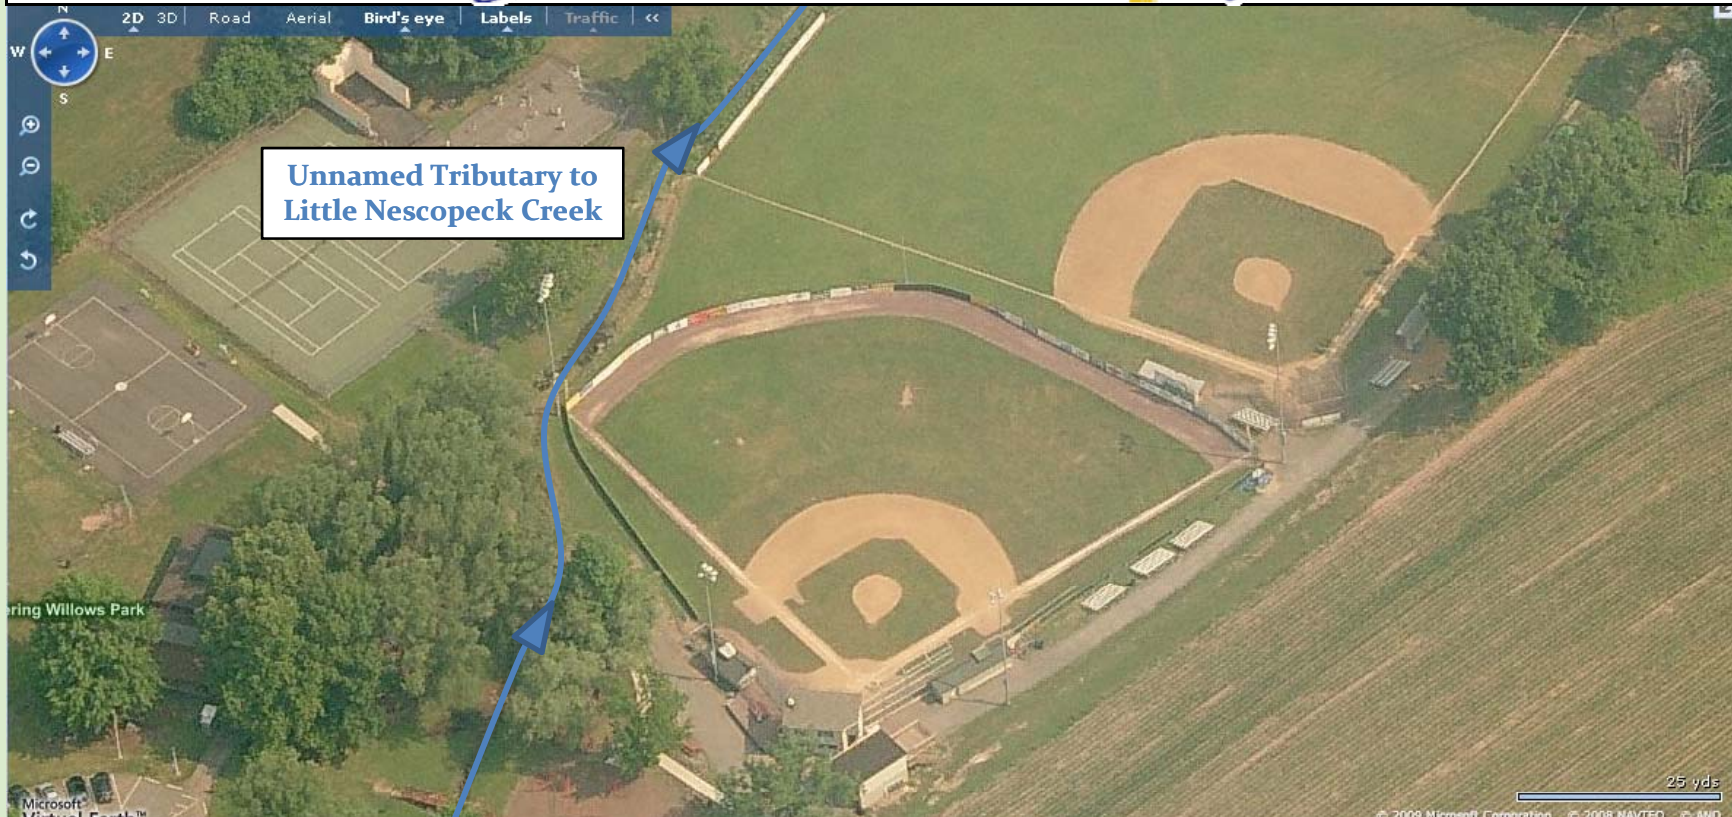
Problem Area	Municipality	Sub Watershed	Stream Name	Preferred Solution
CNBoo4	Conyngham Boro	Nescopeck	Trib to Little Nescopeck Creek	Proposed Solution (A)

Explanation: This is the same reach from Problem Areas CNBoo4, CNBoo5, CNBoo6, and CNBo10. Due to development within the floodplain a number of different problems have arisen. These include flooding, erosion, and water quality issues. Due to the complexity of the problem and the configuration of the existing conveyance, an in-depth analysis is required to see what impacts modification upstream would have as well as if the recreational area can be allowed to flood because no one will be using it during a storm.

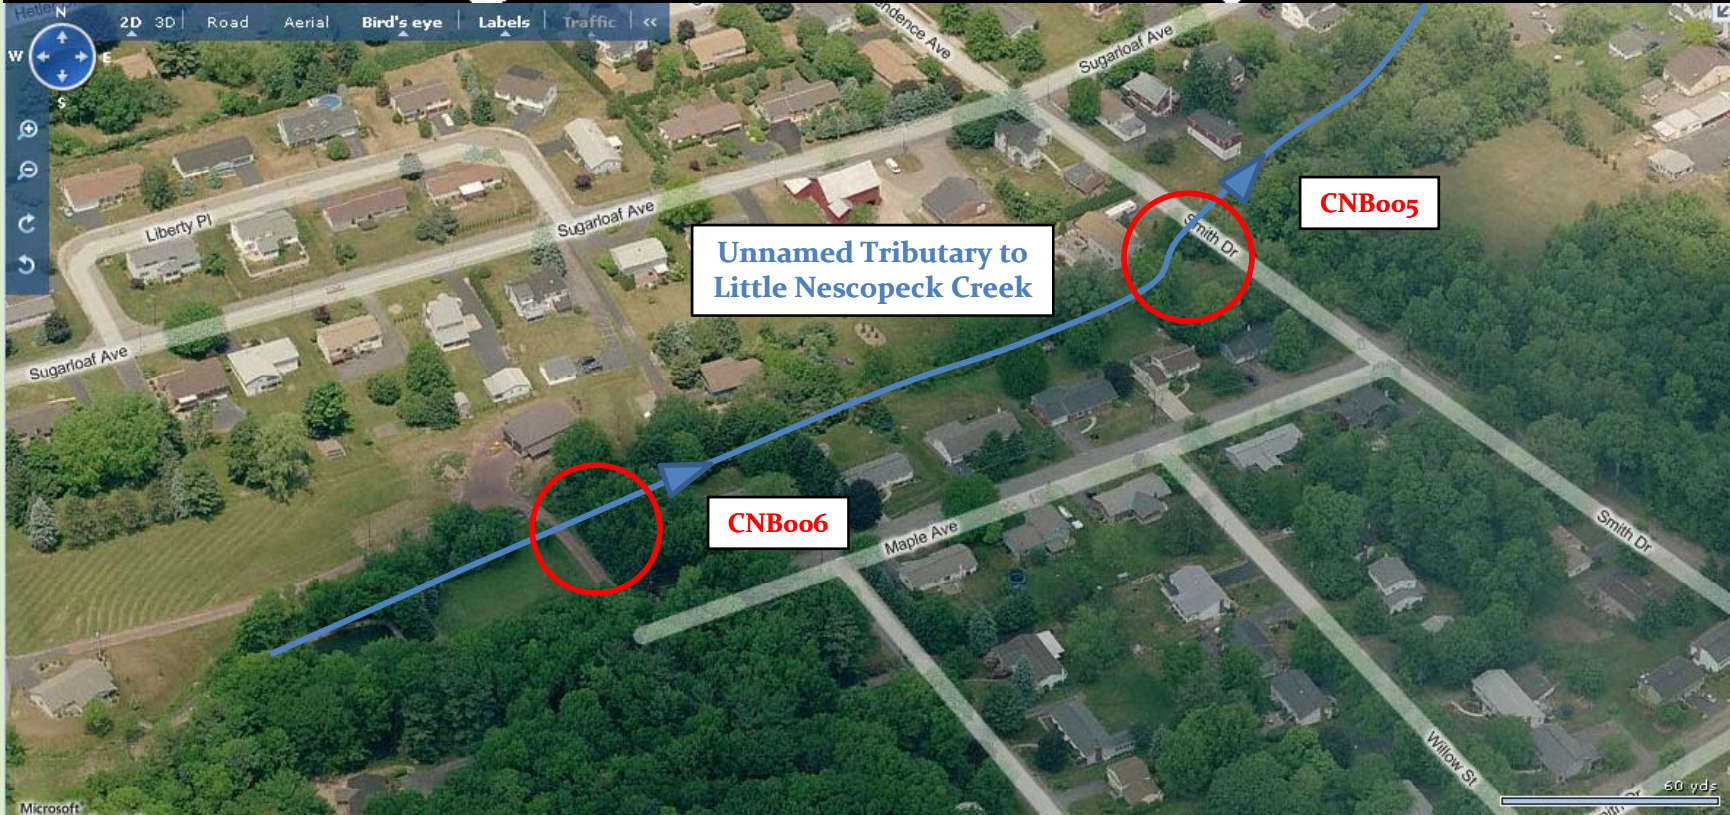
Problem Area	Municipality	Sub Watershed	Stream Name	Preferred Solution
CNBoo5 & CNBoo6	Conyngham Boro	Nescopeck	Trib to Little Nescopeck Creek	Proposed Solution (A)

Explanation: This is the same reach from Problem Areas CNBoo4, CNBoo5, CNBoo6, and CNBoo10. Due to development within the floodplain a number of different problems have arisen. These include flooding, erosion, and water quality issues. Due to the complexity of the problem and the configuration of the existing conveyance, an in-depth analysis is required to see what the impacts of widening the channel, replacing culverts, or removal of downstream obstructions would have on the stream as a whole.

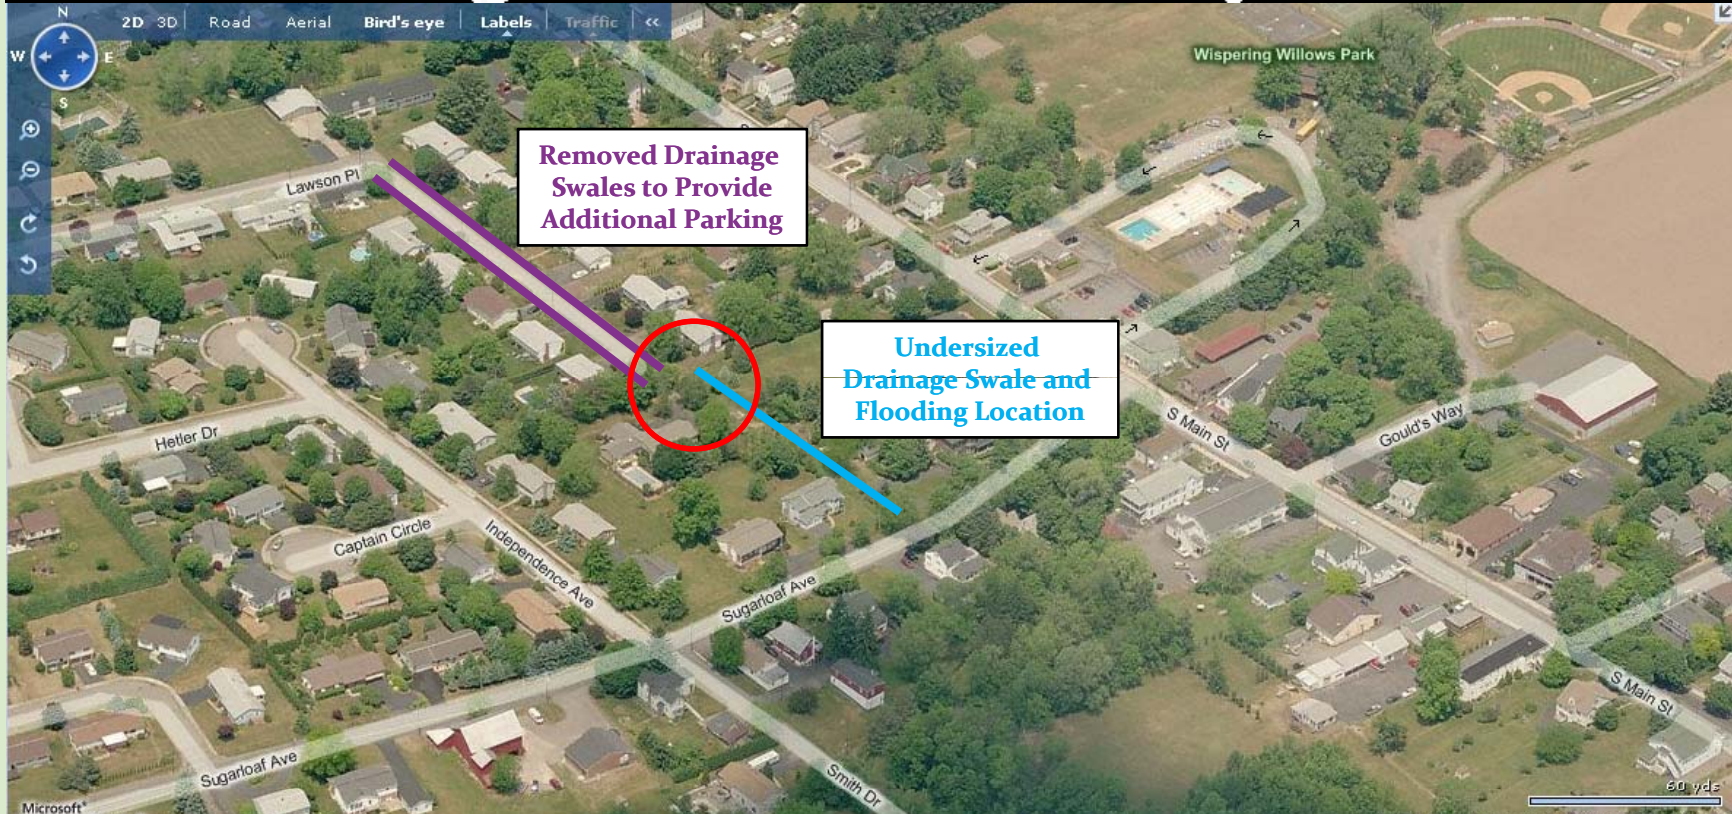
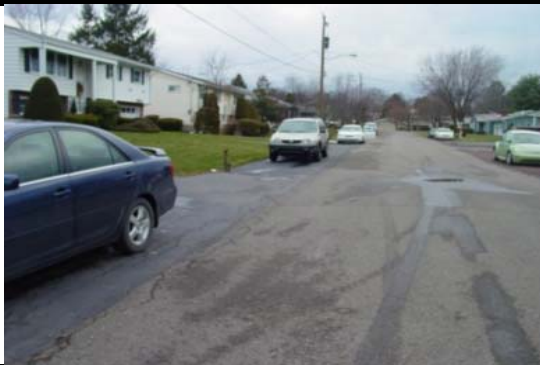
Problem Area ID:	CNB007	Inspected By/Date:	PAK 11/26/2008
Municipality:	Conyngham Borough	Checked By/Date:	DEW 2/26/2010
Subwatershed:	Nescopeck Watershed

Removed Drainage Swales to Provide Additional Parking

Undersized Drainage Swale and Flooding Location

Explanation: At the termination of Lawson Place, uncontrolled runoff is leaving the site and traveling across multiple homes towards the church located on Sugarloaf Avenue and eventually joining with the tributary seen in CNBoo5 and CNBoo6. This problem was believed to be cause due to removal of drainage swales to provide additional parking. Options for correcting include increasing the drainage swales capacity and establishing rain gardens.

Stream name:	Local Drainage		
Drainage Area (mi ²)	0.03		
Calculation Method	Rational Method		
C (Tc)	0.42 (30 min)		
Storm Frequency (Yrs)	Rainfall (in)	Peak Discharge (cfs)	Unit Discharge (cfs/Ac)
2	1.07	16	0.83
10	1.46	21	1.09
25	1.69	24	1.25
50	1.87	27	1.41
100	2.06	30	1.56
500	2.58	37	1.93
*Type of Problem (Highlight all that apply):		Description	
Flooding	Deficient Bridge/Culvert	Drainage travels down on west side of Lawson Place until it crosses a private driveway at the end of the street. From there it enters a swale located between two homes. Local homeowner indicated that an existing roadside swale was removed to provide street parking.	
Erosion	Sedimentation		
Water/Groundwater Pollution	Other		
Potential Solutions			
<p>Repeated flooding at Lawson Place has been identified by the municipality/ Conservation District. Based upon general field observations, this problem is believed to be caused by inadequate conveyance systems, which has resulted in flood damage. Possible solutions to this problem are to provide measures for runoff conveyance such as a vegetated roadside swale or a stormwater inlet and piping system. Further analysis including topographic and property surveys would be required to determine the feasibility of possible solutions.</p>

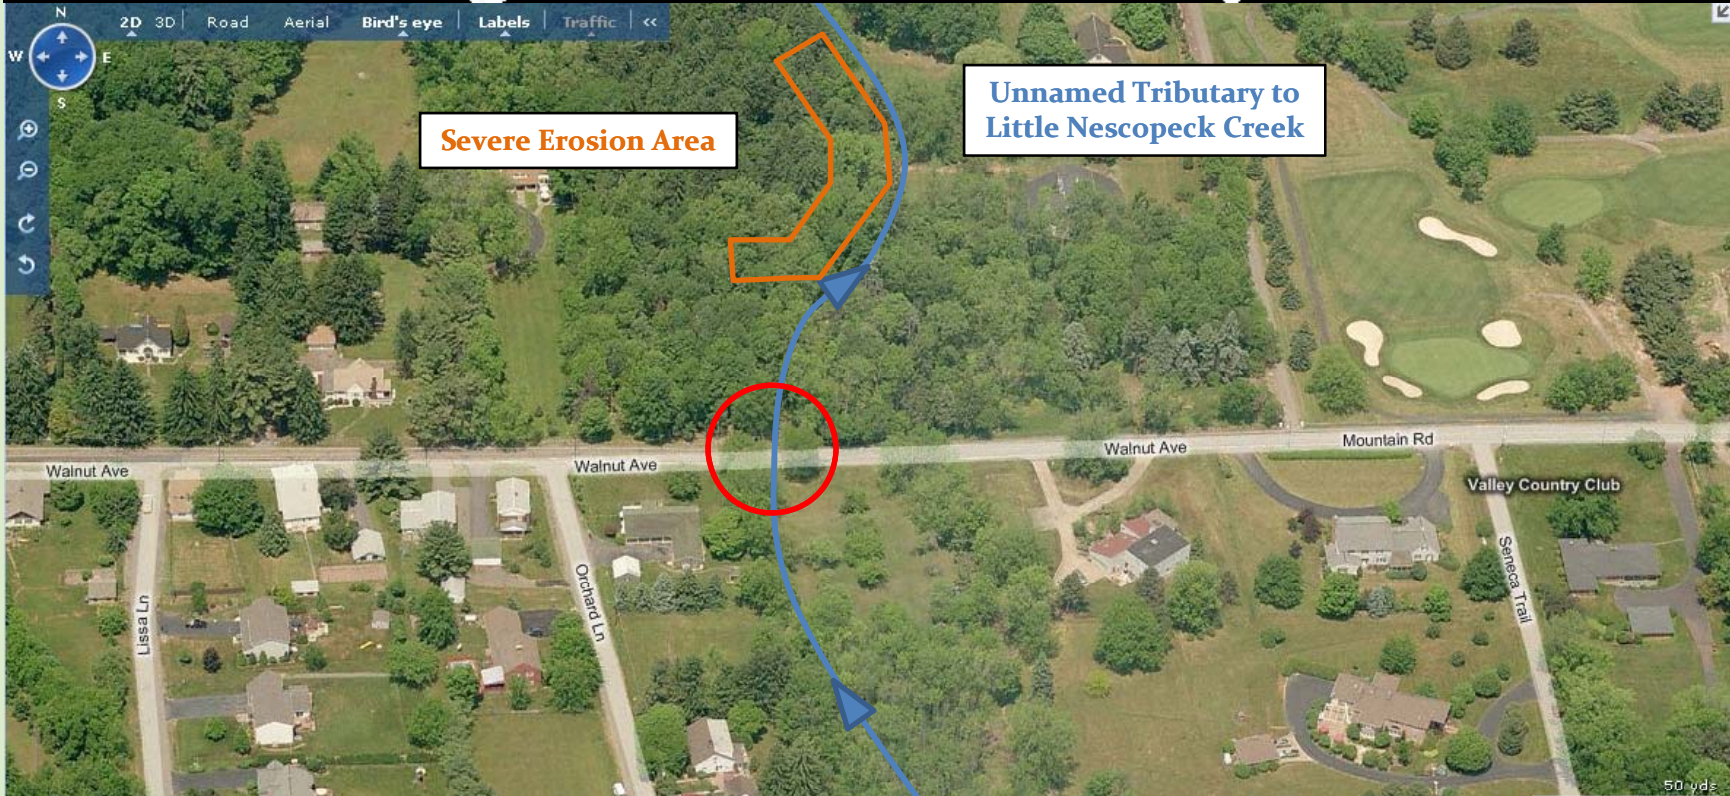
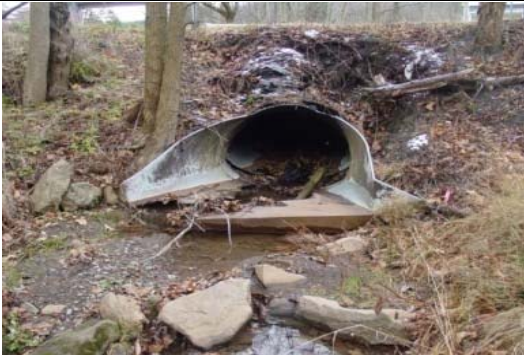
Problem Area ID:	CNB008	Inspected By/Date:	PAK 11/26/2008
Municipality:	Conyngham Borough	Checked By/Date:	DEW 2/26/2010
Subwatershed:	Nescopeck Watershed

Explanation: A CMP culvert under Walnut Avenue appears to be the source of all the problems at this location. Upstream of the culvert houses are flooded, while downstream there is severe erosion which has caused multiple trees to collapse and block flow. Finally, the culvert itself looks like it is beginning to rust. Options for correction include replacement of the culvert, armoring the stream banks downstream, and modifying the channel upstream.

Stream name:	Unnamed Trib to the Little Nescopeck		
Drainage Area (mi ²):	0.12		
Calculation Method:	Rational Method		
C (Tc):	0.28 (30 min)		
Storm Frequency (Yrs)	Rainfall (in)	Peak Discharge (cfs)	Unit Discharge (cfs/Ac)
2	1.07	47	0.61
10	1.46	64	0.83
25	1.69	74	0.96
50	1.87	81	1.05
100	2.06	90	1.17
500	2.58	113	1.47
*Type of Problem (Highlight all that apply):		Description	
Flooding	Deficient Bridge/Culvert	An undersized CMP culvert under Walnut Ave appears to be the source of flooding at this location. Flooding is reported upstream of the culvert. In addition to being undersized, the culvert is also in a deteriorated condition due to rusting. Streambank erosion downstream of the culvert is also present.	
Erosion	Sedimentation		
Water/Groundwater Pollution	Other

Potential Solutions			
Repeated flooding upstream of the culvert has been identified by the municipality/ Conservation District. Based upon general field observations, this problem is believed to be caused by insufficient capacity. Streambank erosion is also present downstream of the culvert which has undermined several trees. Possible solutions include (A) replacing the culvert under Walnut Ave and (B) stabilizing the downstream channel.			
Cost Estimates			
Option	A	B	C
Cost Range	\$10,000-\$20,000	\$5,000	N/A

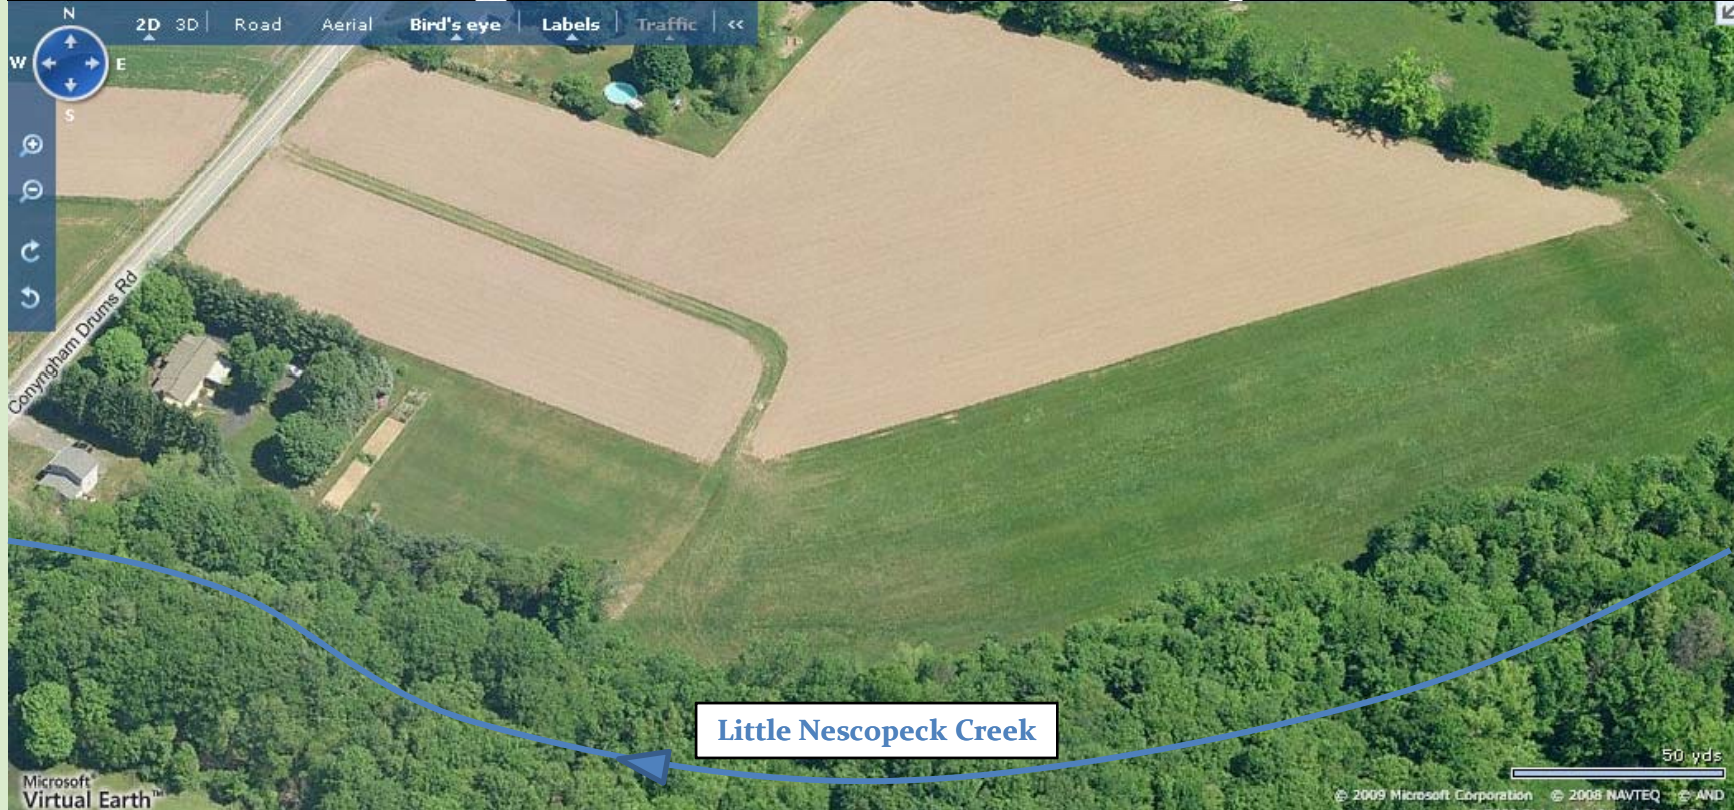
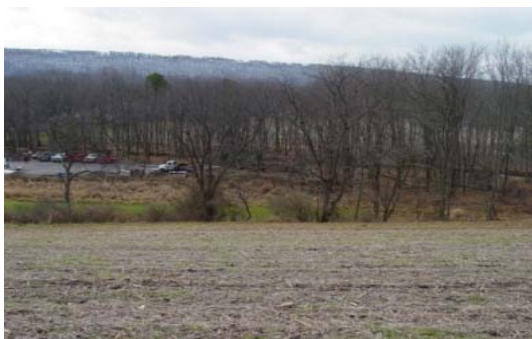
Problem Area ID:	CNB009 & SUG003	Inspected By/Date:	PAK 11/26/2008
Municipality:	Conyngham Borough	Checked By/Date:	DEW 2/26/2010
Subwatershed:	Nescopeck

Explanation: This area adjacent to the Little Nescopeck Creek appears to be about the discharge points from multiple farms located up gradient. Additionally, acid mine drainage has been detected in the area. As such, this area is a major entry point for nonpoint source pollutions. Options for correction involve establishment of proper nutrient programs and agricultural methods for the farms, establishing buffers between the individual farms and increasing the buffer between the Little Nescopeck and the last farm.

Stream name:	Little Nescopeck		
Drainage Area (mi ²):	10.7		
Calculation Method:	NSS StreamStats		
C (Tc):	N/A		
Storm Frequency (Yrs)	Rainfall (in)	Peak Discharge (cfs)	Unit Discharge (cfs/Ac)

2.33	3.40	519	0.08
5	4.22	904	0.13
10	4.95	1210	0.18
25	6.10	2030	0.30
50	7.16	2440	0.36
100	8.43	3570	0.52
*Type of Problem (Highlight all that apply):		Description	
Flooding	Deficient Bridge/Culvert	Numerous reports have listed water quality problems in this area. Numerous farms and mines are located in this area which may be the cause of both stormwater and groundwater quality problems.	
Erosion	Sedimentation		
Water/Groundwater Pollution	Other		
Potential Solutions			
Possible solutions to the water quality problems would include establishing more effective vegetated buffers between the farm land and streams along with mine reclamation. Due to the extent and complexity of the problem, further investigation would be required to determine the most effective solution and associated costs.			
Cost Estimates			
Option	A	B	C
Cost Range	N/A	N/A	N/A

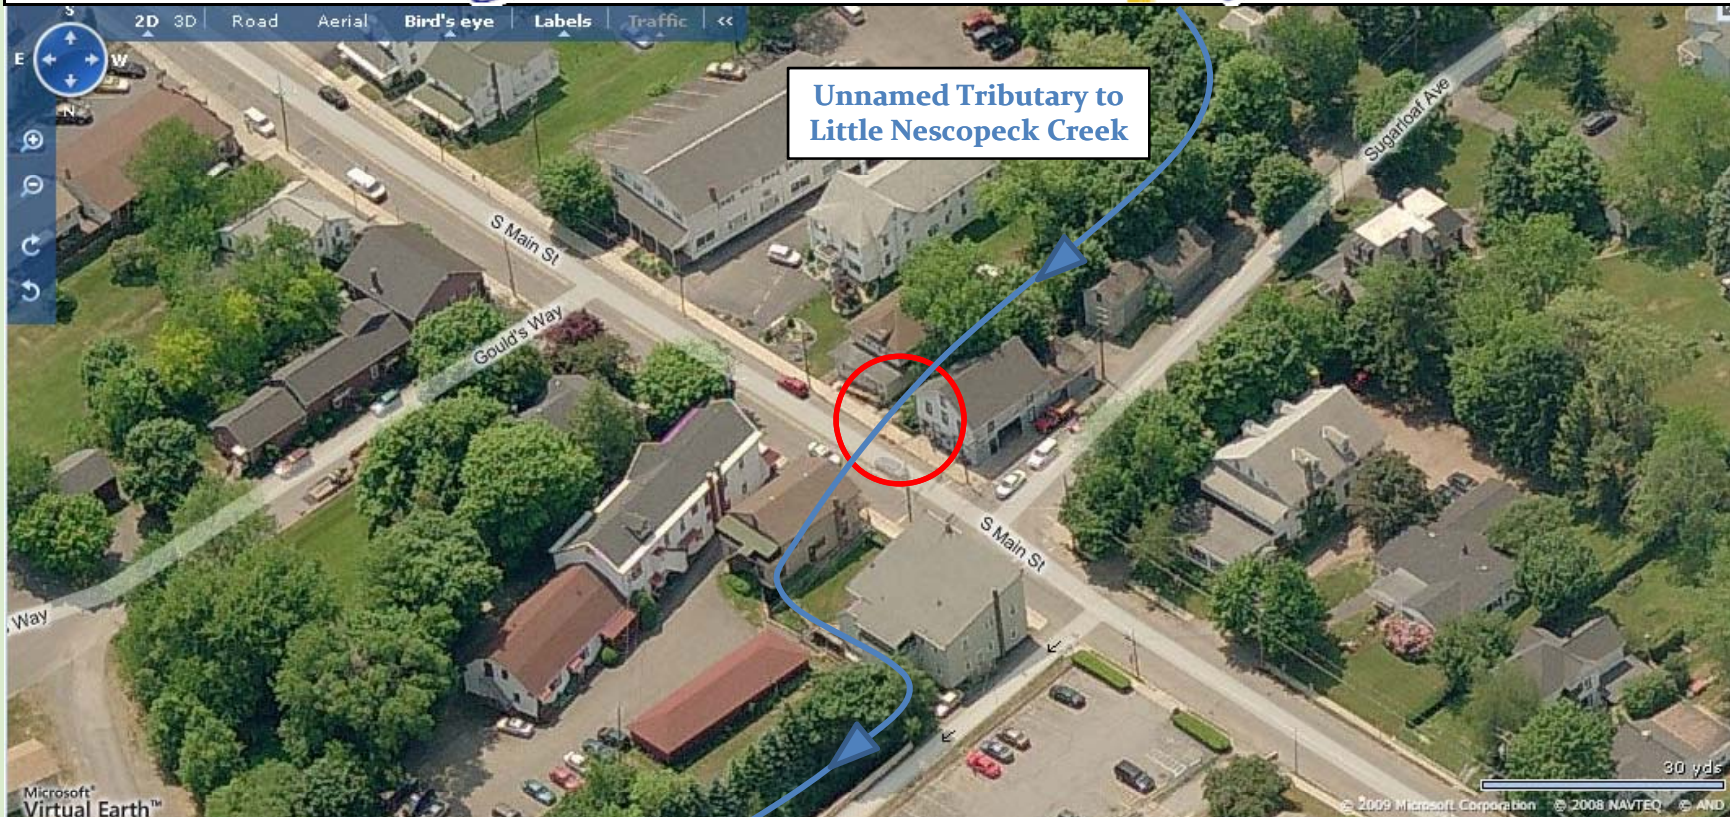
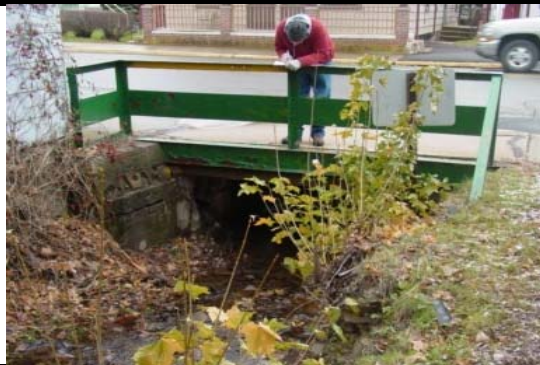
Problem Area ID:	CNB010	Inspected By/Date:	PAK 11/26/2008
Municipality:	Conyngham Borough	Checked By/Date:	DEW 2/26/2010
Subwatershed:	Nescopeck Watershed

Explanation: This is the same reach from Problem Areas CNBo04, CNBo05, CNBo06, and CNBo10. Due to development within the floodplain, a number of different problems have arisen. These include flooding, erosion, and water quality issues. Due to the complexity of the problem and the configuration of the existing conveyance, an in-depth analysis is required to see what the impact removal of the house or reestablishing the buffer would have upon the tributary as a whole.

Stream name:	Trib to Little Nescopeck		
Drainage Area (mi ²):	0.6		
Calculation Method:	USGS 2000-4189		
C (Tc):	N/A (N/A)		
Storm Frequency (Yrs)	Rainfall (in)	Peak Discharge (cfs)	Unit Discharge (cfs/Ac)
2	3.16	121	0.32
5	3.91	192	0.50
10	4.57	270	0.70
50	6.53	339	0.88
100	7.63	419	1.09
500	10.98	652	1.70
*Type of Problem (Highlight all that apply):		Description	
Flooding	Deficient Bridge/Culvert	This location is upstream from CNB001. Homes are located on the top of banks approximately 150 feet upstream of culvert under Main Street. Stream erosion is present.	
Erosion	Sedimentation		
Water/Groundwater Pollution	Other		
Potential Solutions			
<p>Flooding, and water pollution problems along the tributary to Little Nescopeck Creek have been identified by the Municipality in the vicinity of South Main Street. This is the same reach from Problem Areas CNB001, CNB004, CNB005, and CNB006. Based upon general field observations these problems are most likely due to development within the floodplain. Due to the complexity of the problem and configuration of existing conveyance, a more in-depth analysis of the problem area is required. Solutions should consider reestablishment of the floodplain though the reach.</p>

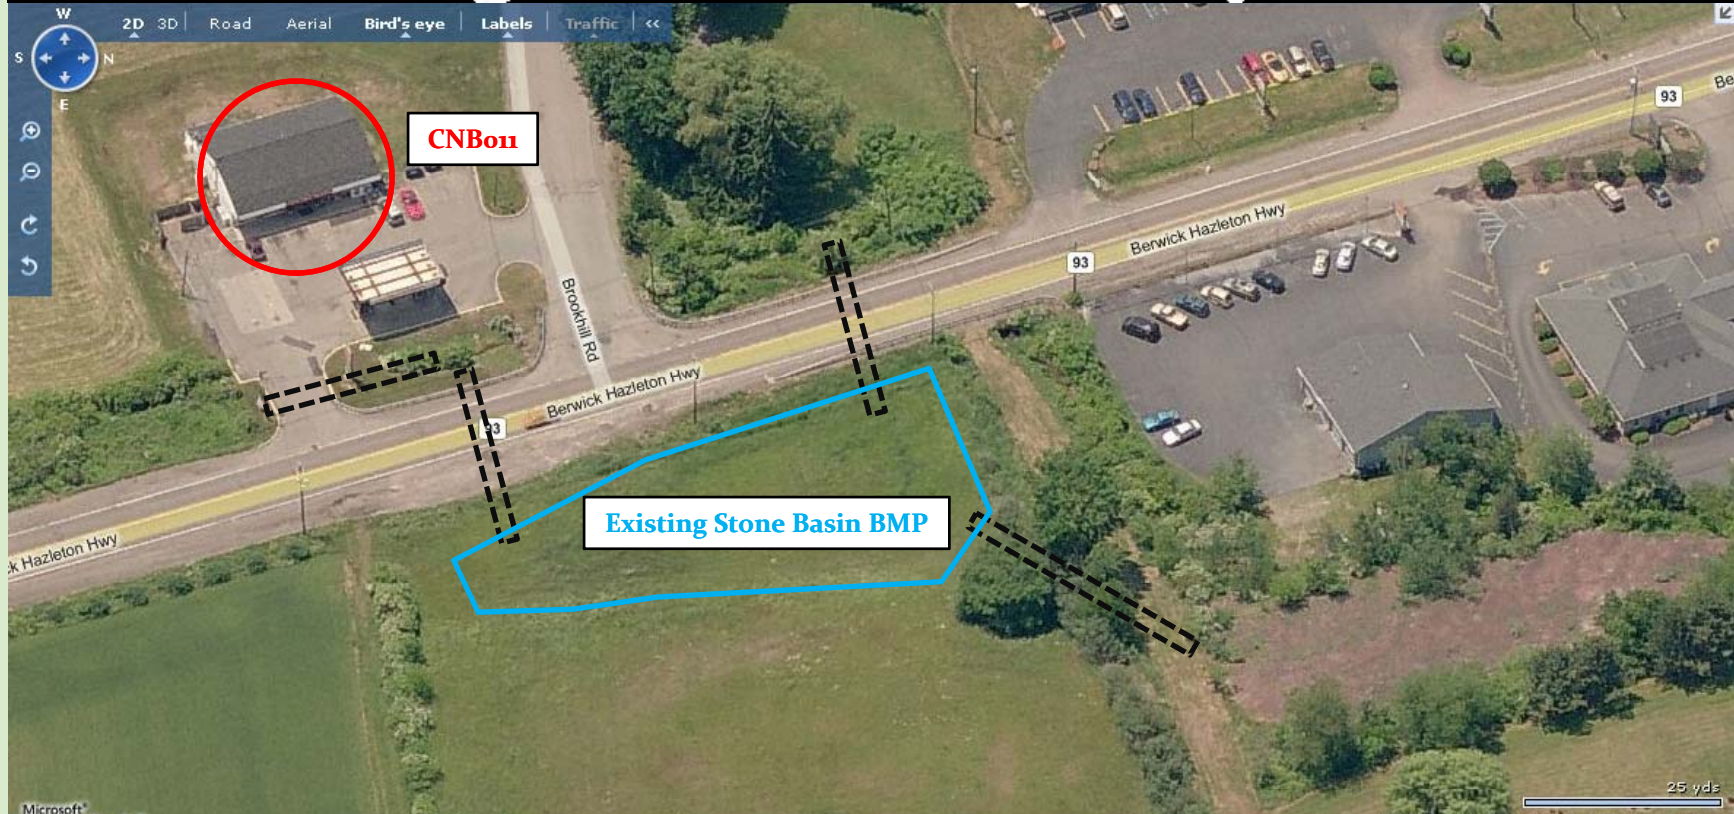
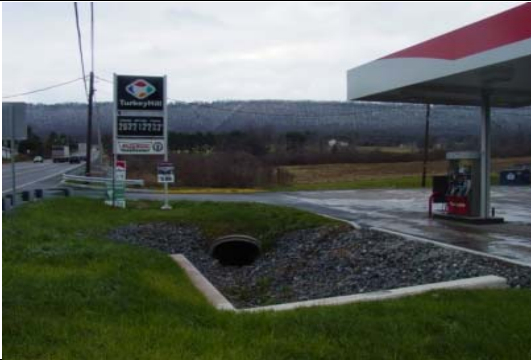
Problem Area ID:	CNB011	Inspected By/Date:	PAK 11/26/2008
Municipality:	Conyngham Borough	Checked By/Date:	DEW 2/26/2010
Subwatershed:	Nescopeck Watershed

Explanation: This is the same reach from Problem Areas CNBo02. The municipality writes that this is a location of water quality issues, and on the map pinpointed the gas station. While the Turkey Hill could be a point source of pollution, Route 93 is a principal arterial connection though the area and a possible nonpoint source pollutant. Options for correction include replacing the stone in the Turkey Hill bmp with natural vegetation and installing a water quality bmp along the road.

Stream name:	Trib to the Little Nescopeck Creek		
Drainage Area (mi ²):	0.56		
Calculation Method:	USGS 2000-4189		
C (Tc):	N/A (N/A)		
Storm Frequency (Yrs)	Rainfall (in)	Peak Discharge (cfs)	Unit Discharge (cfs/Ac)
2	3.40	102	0.28
5	4.22	142	0.40
10	4.95	169	0.47
25	6.10	248	0.69
50	7.16	319	0.89
100	8.43	406	1.13
*Type of Problem (Highlight all that apply):		Description	
Flooding	Deficient Bridge/Culvert	Potential sources of water quality problems at this location include runoff from the Turkey Hill gas station and roadside runoff.	
Erosion	Sedimentation		
Water/Groundwater Pollution	Other		
Potential Solutions			
Water quality problems have been identified by the Municipality at this location. Based upon general field observations, this problem is believed to be caused by a lack of pretreatment of the surface runoff from the Turkey Hill gas station and/or roadway. Solutions could include (A) installing a manufactured water quality device on the Turkey Hill property, (B) converting the rock lined basin into a vegetated BMP, and (C) establishing more effective vegetated BMPs along the roadway.

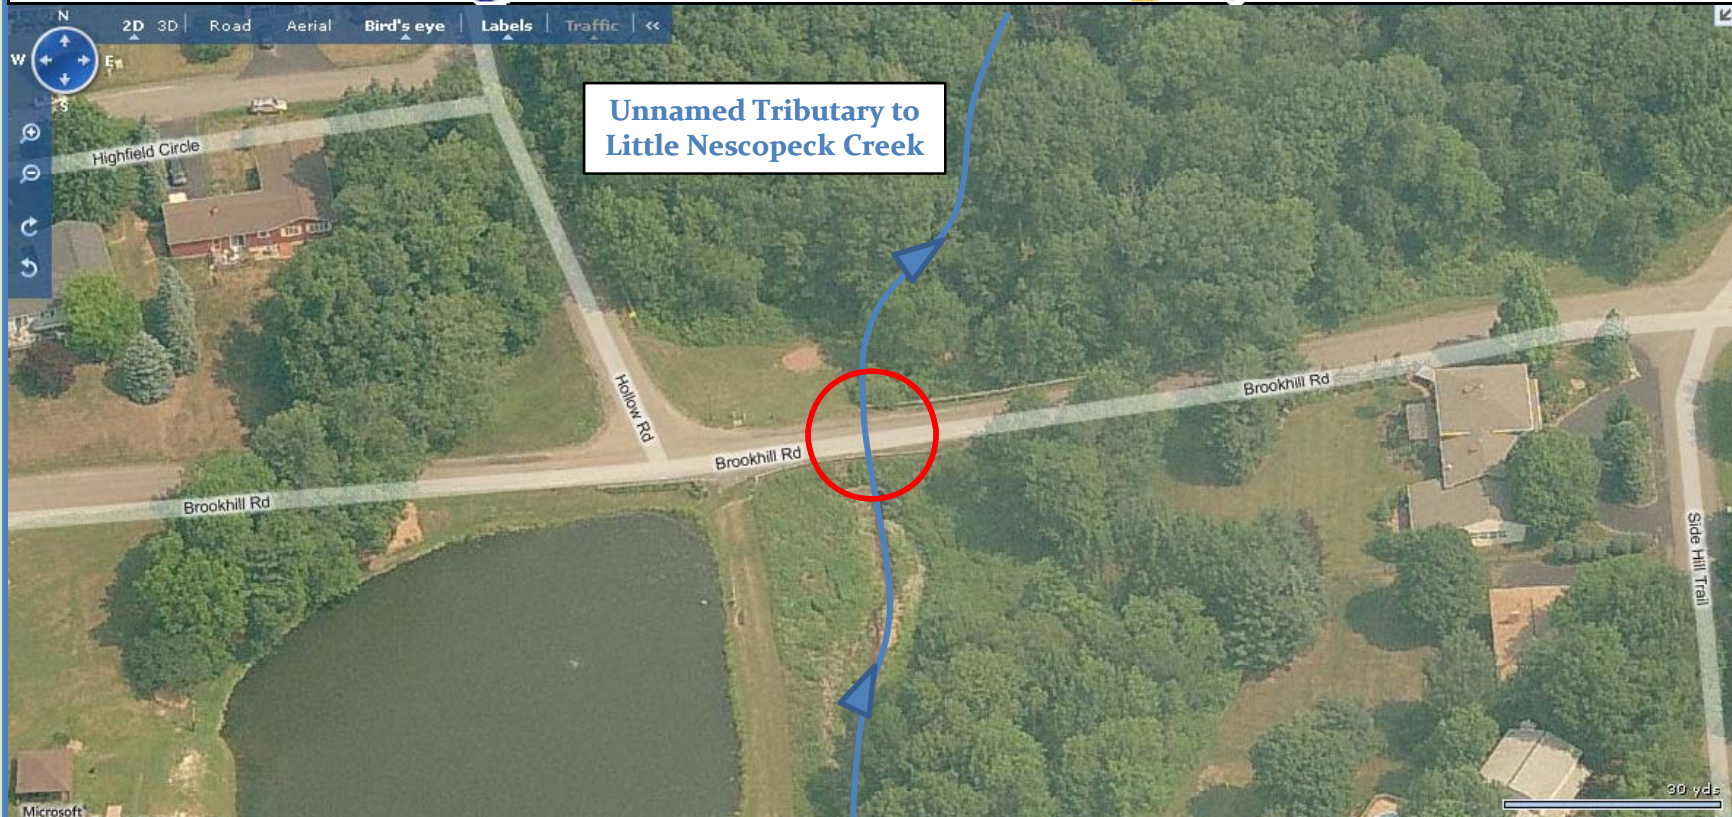
Problem Area	Municipality	Sub Watershed	Stream Name	Preferred Solution
CNBo12	Conyngham Boro	Nescopeck	Trib to Little Nescopeck Creek	Proposed Solution (N/A)

Explanation: Water quality issues have been reported by the municipality at this reach by Brookhill Road. Site observation noted that erosion has caused a channel of sort that allows stormwater runoff carrying nonpoint source pollution to drain directly into the stream. Additionally, no buffer is present and the grass is mowed up to the stream banks. Options for correction include fixing the erosion channel that allows for nonpoint source pollution direct entry to the stream and establishing a buffer along the stream.

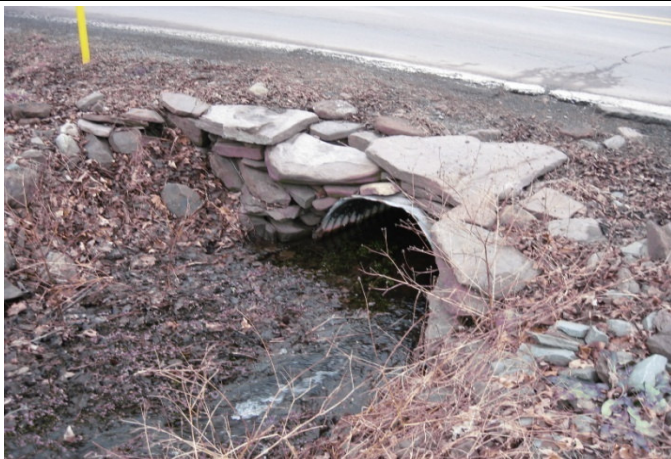
Problem Area - Map ID:	DEN001	<p style="text-align: center;">Comments</p> <p>Flooding problems were identified in the vicinity of 7th Street and Middleburg Road by Dennison Township. According to the municipal documentation, adequate drainage is not provided under nearby railroad tracks. Site observation revealed the apparent problem to be an undersized culvert and swale along 7th street that is conveyed under Middleburg Road. The railroad tracks appeared to be significantly downgradient and not a cause of flooding.</p>
Municipality:	Dennison Township	
Subwatershed:	Lehigh River	
Stream name:	Local Drainage	
Inspected By/Date:	PAK 1/21/20010	
Checked By/Date:	DEW 2/3/2010	
Type of Problem (Highlighted):		
1	Flooding	
2	Deficient bridge/culvert	
3	Erosion	
4	Sedimentation	
5	Water/Groundwater Pollution	
6	Other

Upstream face of culvert under Middleburg Road. Middleburg Road is presumed to be the state road identified as having a history of flooding. Based upon site observations this culvert is likely the cause of the flooding. Culvert is partially clogged and could be potentially undersized.

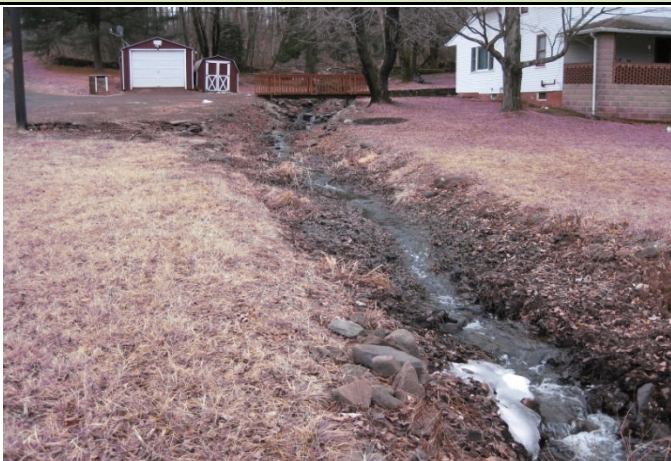
Channel upstream of the culvert. The channel may not have capacity to handle large flows. Both banks have begun to erode due to the steep topography of the area which results in high water velocities.

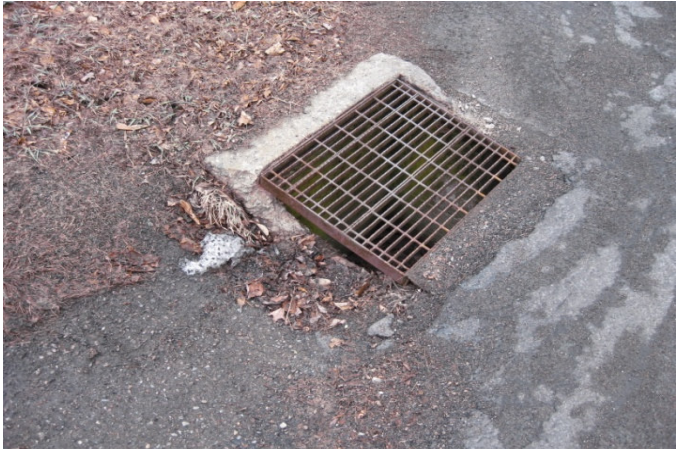
<div style="width: 50%; padding-left: 10px;"> <p>Storm Sewer Inlet from swale. Although not indicated by the forms, erosion is another problem at this location. Part of the storm sewer inlet has eroded, and runoff enters directly into the sewer without passing through the grate.</p> </div> </div>

Solution	5.7.1, 6.4.8, 6.4.4, 6.A, 6.B, 6.C
----------	------------------------------------

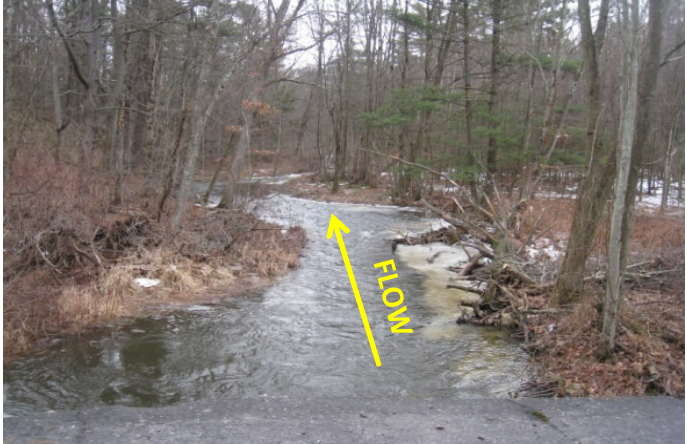
Looking downstream of culvert. Erosion present along both banks, with exposed roots visible on the right bank.

Solution	5.4.2, 6.7.1, 6.A, 6.B, 6.C
----------	-----------------------------

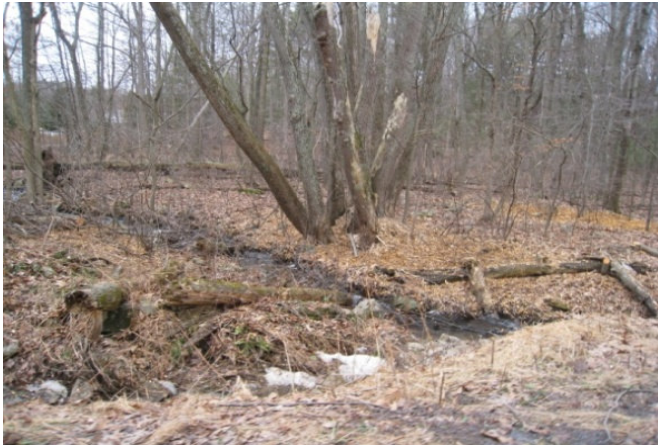
<p>General problem vicinity. Due to the dense vegetation, the exact location of the problem could not be determined.</p>

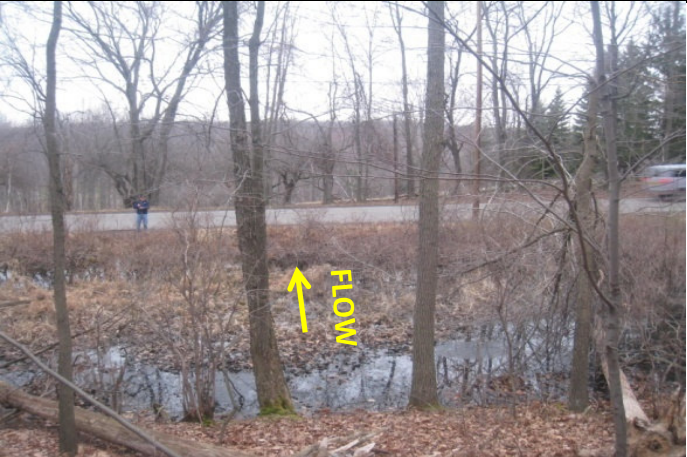
<p>Ponding water ponding upstream of the culvert. Note that there was no rain for several days before this photo was taken</p>

Solution	6.4.5, 6.4.8, 6.A, 6.B, 6.C, 6.D
----------	----------------------------------

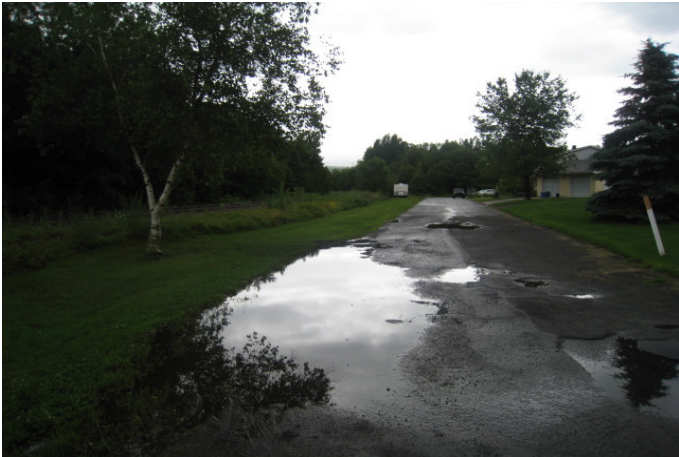
<div style="width: 50%; padding-left: 10px;"> <p>Ponding water along Oak Street (looking south) several hours after a rain event. The Borough indicated that local drainage was a problem in this general area due to the absence of positive drainage or collection and conveyance systems.</p> </div> </div>

Solution	6.B Storm Sewer
----------	-----------------

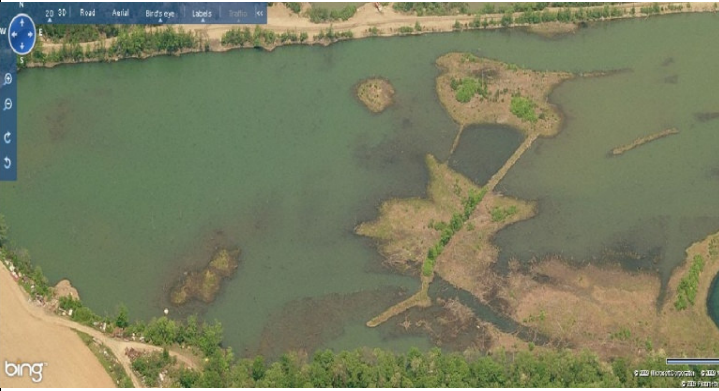
Aerial photograph showing the northern portion of the problem area. Overflow from the Lackawanna River appears to pond in this area.

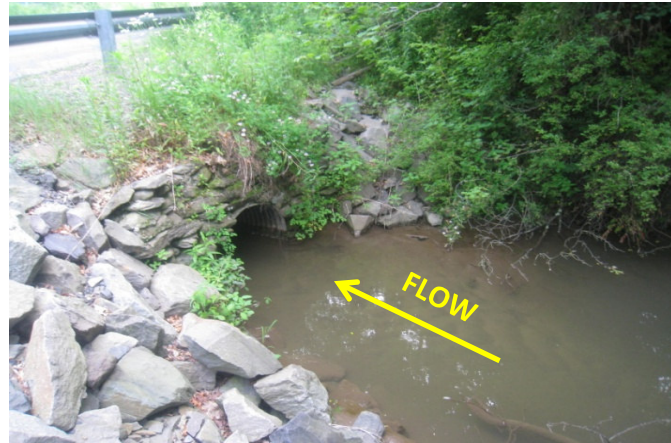
Description
	Looking at upstream end of 24" CMP, which runs beneath Dymond Road. Riprap is located along the left streambank.

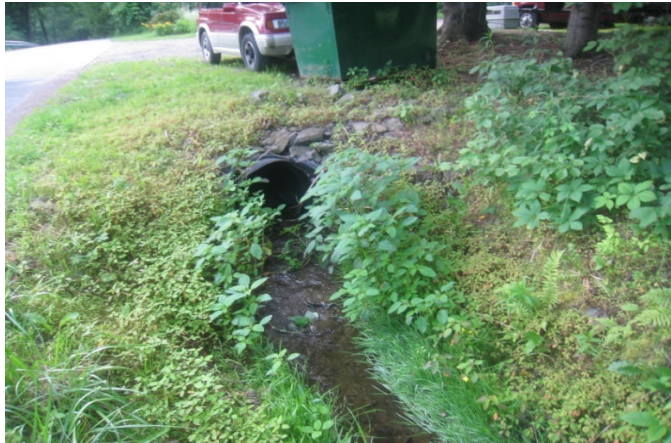
</div> <div style="width: 5%;"></div> <div style="width: 45%;"> <p>An HDPE culvert under a private driveway along Lockville Road.</p> </div>

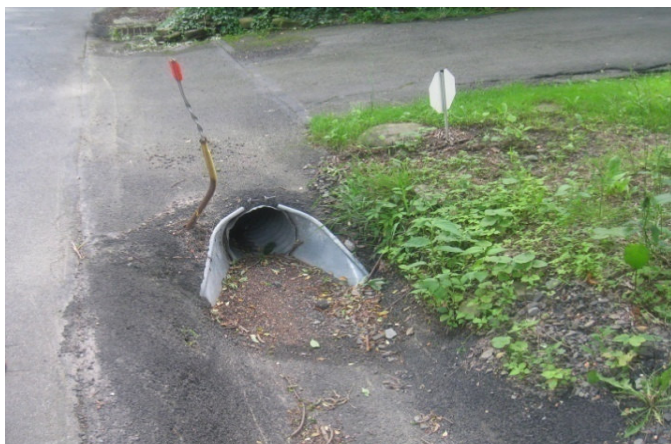
</div> <div style="width: 5%;"></div> <div style="width: 45%;"> <p>CMP culvert under another private driveway along Lockville Road. Debris and sedimentation is noticeable at the culvert inlet.</p> </div>

Solution	6.4.4, 6.4.5, 6.4.8, 6.A, 6,B, 6.C, 6.D
----------	---

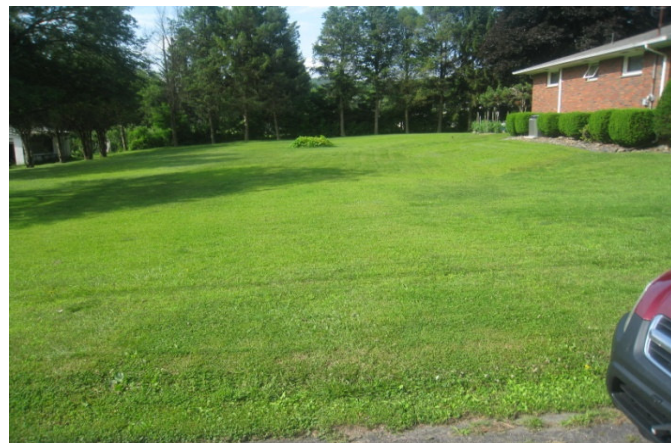
</div> <div style="width: 50%; padding-left: 10px;"> <p>This photo shows one of the lawns along Wilson Avenue.</p> </div>

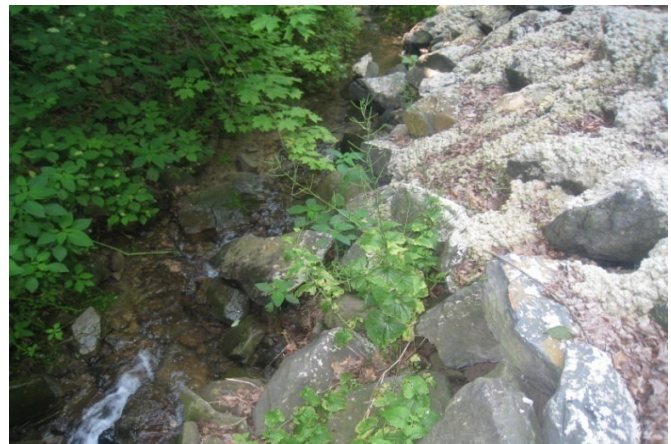
<p>Grouted riprap downstream of the bridge. A gabion wall (not shown) is located between the riprap and the culvert.</p>

Solution	5.4.2, 6.7.1, 6.A, 6.B, 6.C, 6.D
----------	----------------------------------

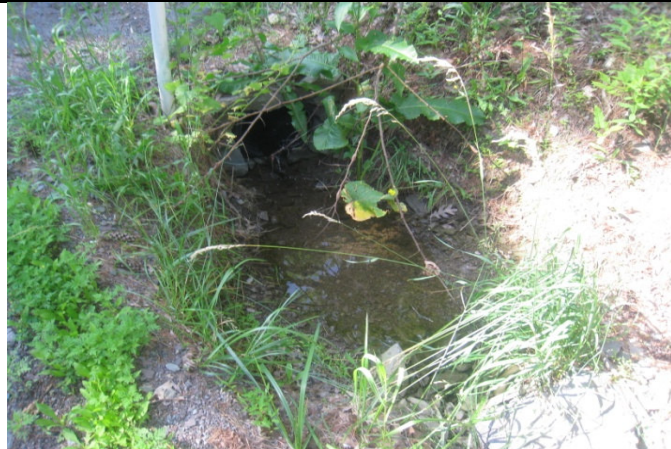
Description
	Looking at upstream end of an HDPE culvert inlet under a gravel driveway which is part of a swale that runs along Bodle Road.
